**Nobel House**  
**4 Queensway, Redhill RH1 1TY**

**Façade Inspection Summary Report**

**On behalf of Y&Y Management**

July 2020

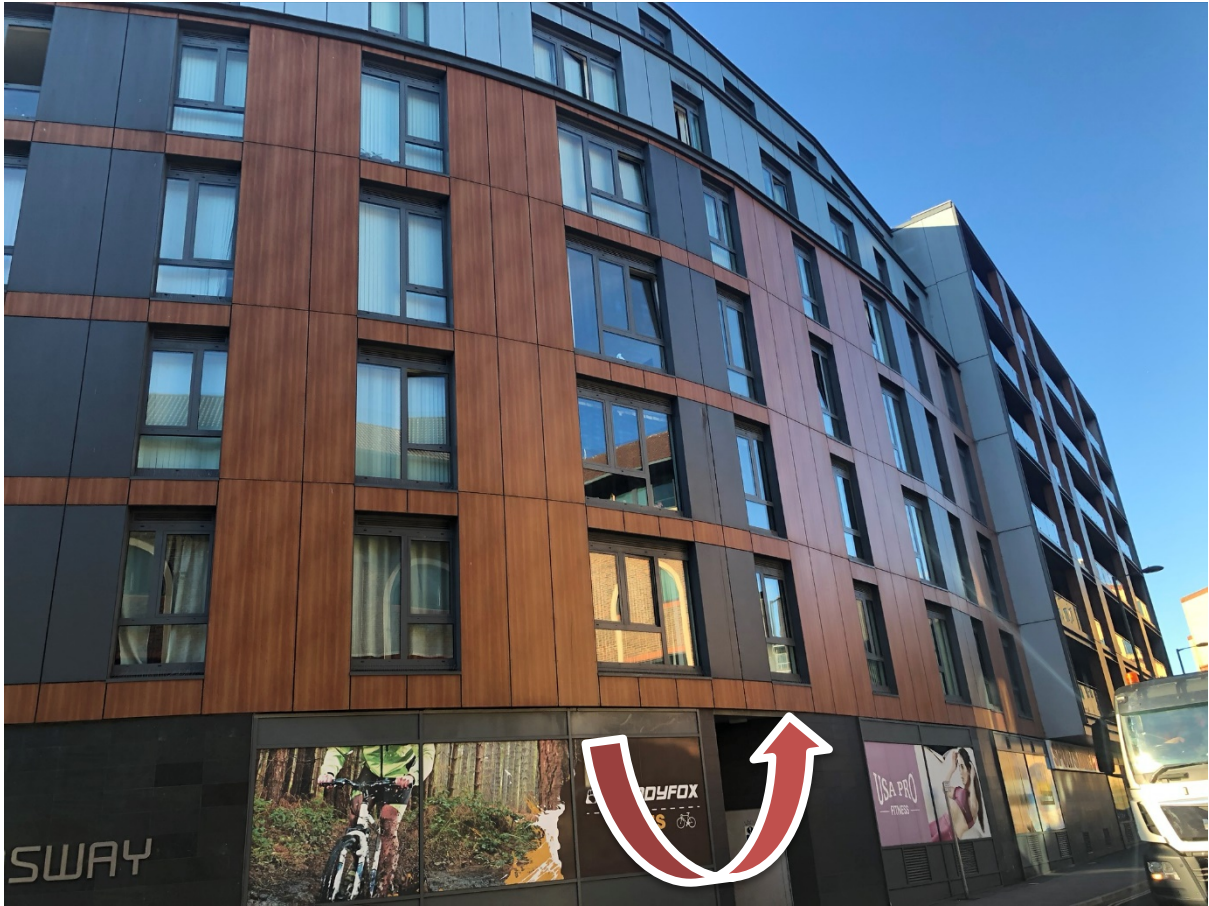
Figure 2 – Main elevation – Inspection Location Area 2

The soffit at Location Area 2 is clad with fluted effect 'Timber' decking boards, which have been painted, these are supported on softwood battens which are fixed to the underside of the concrete slab above.

These battens help support the insulation applied to the face of the concrete slab-edge, we do not believe that the insulation is manufactured from correctly certified fire-stop material.

Unfortunately, it is not rigidly fixed to the slab edge, as you would expect with galvanised metal support fixings and a closure plate to ensure a compliant detail.

We believe the existing detail presents an immediate combustible material risk in its current condition, given the extensive reliance on the timber cladding, associated framework and lack of fire-stopping.

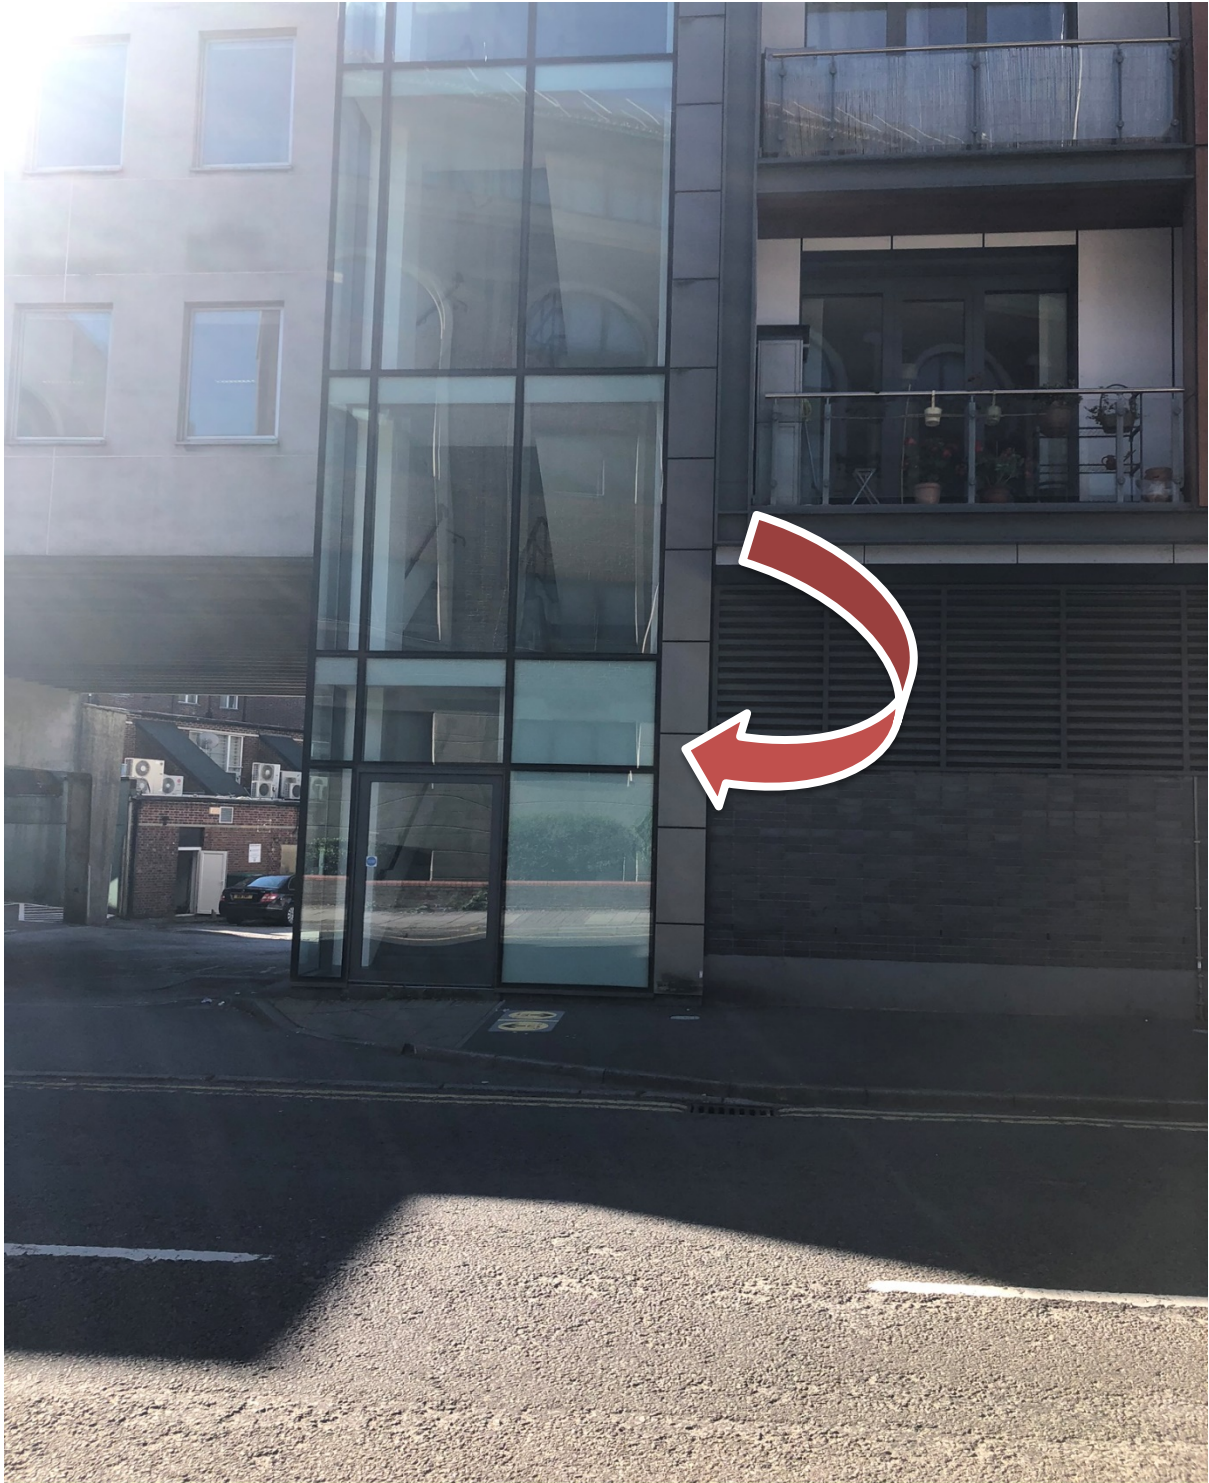
Figure 3 – Main elevation – Inspection Location Area 1

1. composite metal rainscreen cladding, it is highly likely that this is fabricated from now prohibited ACM material, product and system unknown, this is supported on aluminium rails and helping hand brackets, fixed back to a blockwork substrate, there was no visible insulation, fire-stops and or cavity barriers observed within the cladding zone in this location.

However, for the avoidance of doubt and based upon our extensive industry experience we, believe that the existing composite metal rainscreen is of the ACM variety.

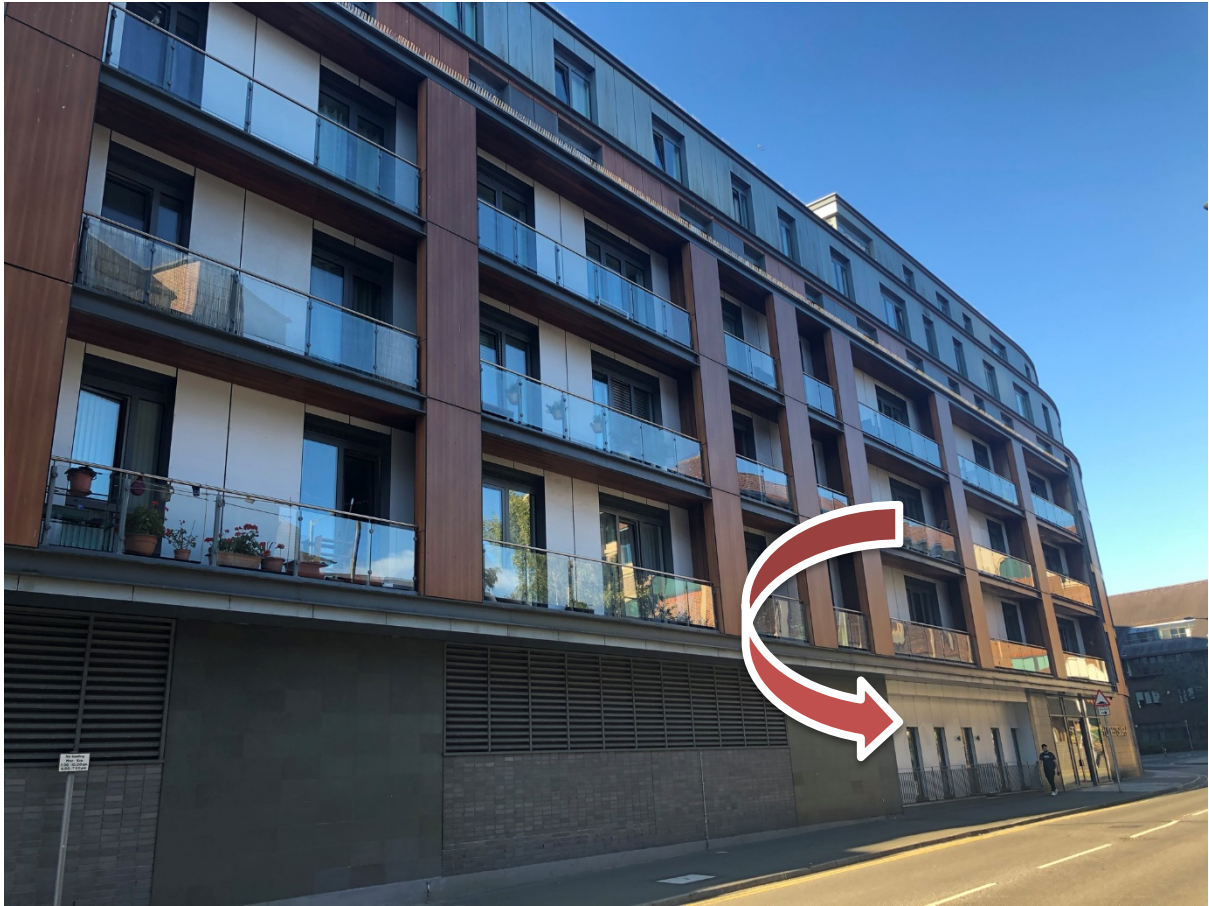
**Figure 7 – Main elevation – Inspection Location Area 3**

Similar to a good majority of the façade on the property, the cladding product used at Location Area 3 is high pressure laminated board.

In this case we believe it was manufactured by Vivalda Ltd, who are an established façade industry system supplier.

We were fortunate enough to remove a sample board with product markings still visible to the rear board, which is a 10mm thick and possibly a Trespa type board, which will be of assistance moving forward to research the exact specification details for certain elements of the façade.

Again, in a similar vein to our discovery at Location 2, the cladding is fixed back to softwood battens but these are supported on a blockwork wall, which is sheathed in a 'House-wrap' breather membrane.

We can confirm that there was no visible insulation, fire-stops and or cavity barriers observed within the cladding zone in this location.

We believe that the existing detail presents an immediate combustible material risk in its current condition, given the extensive reliance on the timber in the associated framework and lack of fire-stopping.

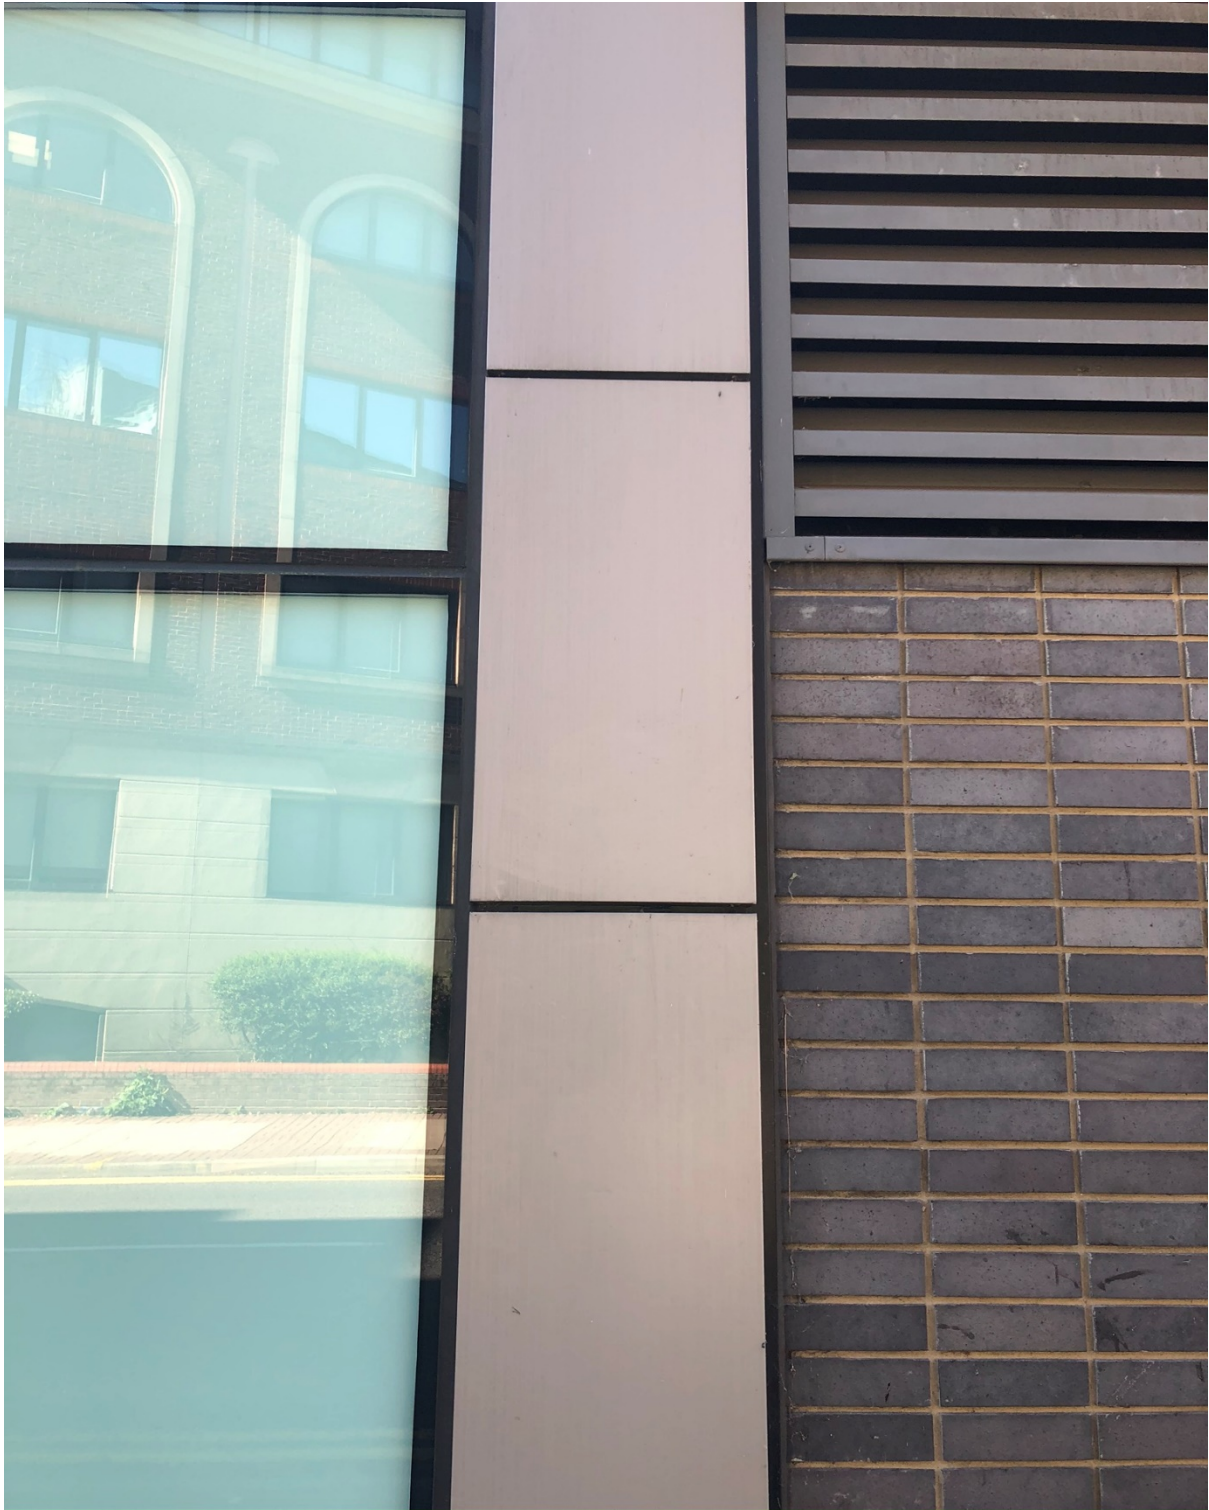
**Figure 8 – Inspection Area 1 – existing composite metal rainscreen cladding (ACM) at junction between SG curtain walling and tiled masonry.**

In particular the sample of the composite metal rainscreen cladding removed and observed at *Location Area 1*, dialogue has commenced with our preferred testing house to undertake material analysis and reaffirm our belief that the panel is combustible ACM.

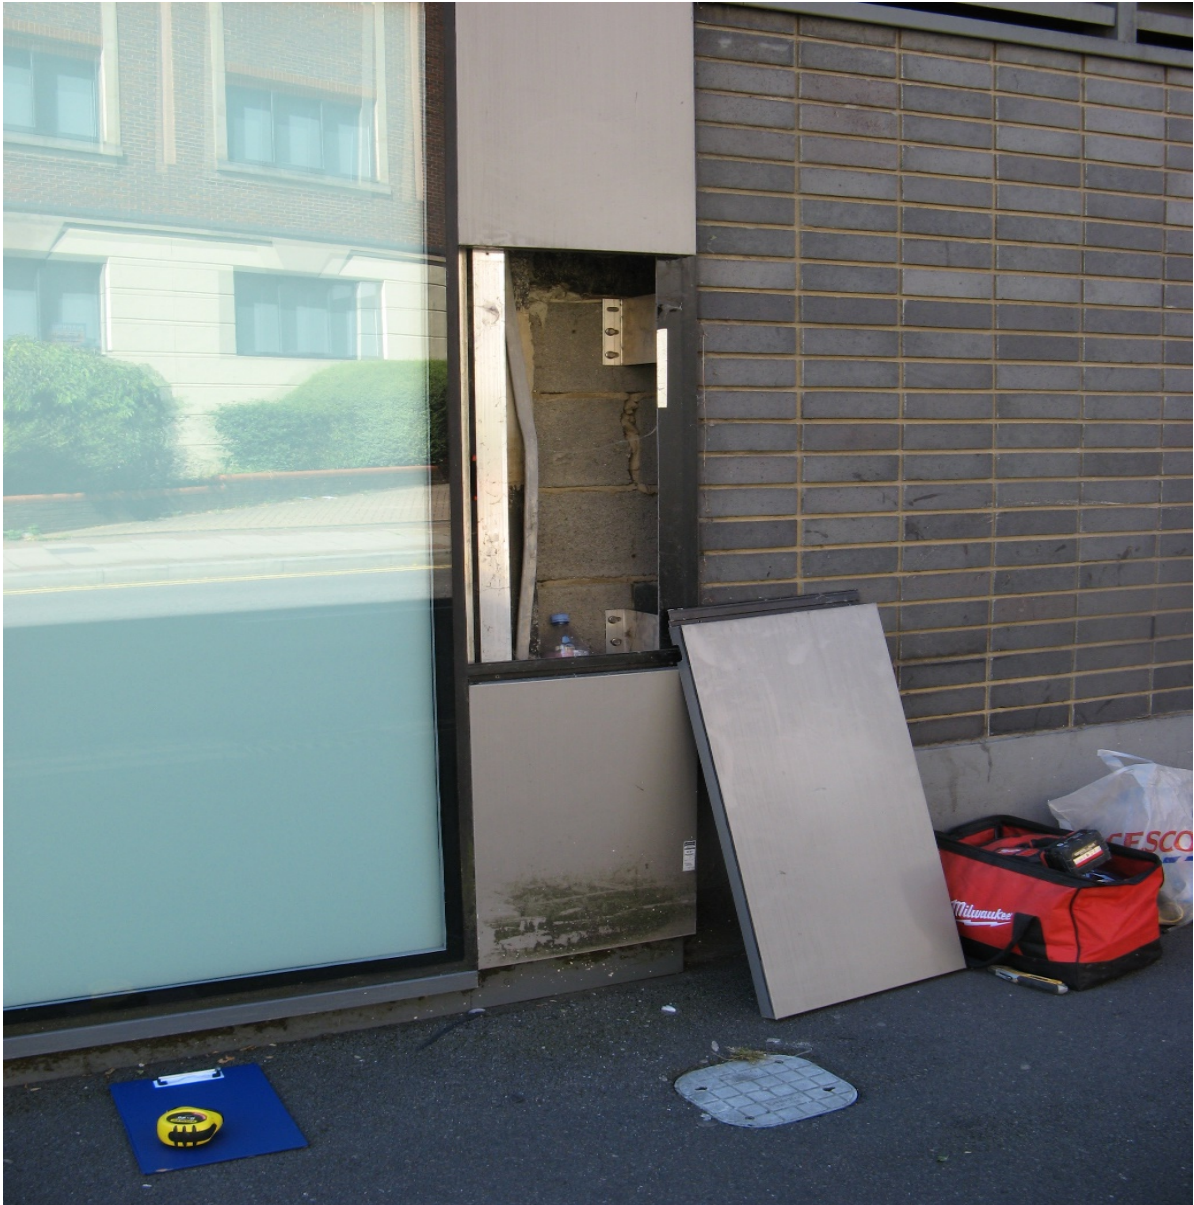
**Figure 9 – Inspection Area 1 - existing composite metal rainscreen cladding (ACM) at junction between SG curtain walling and tiled masonry, exposing blockwork substrate behind.**

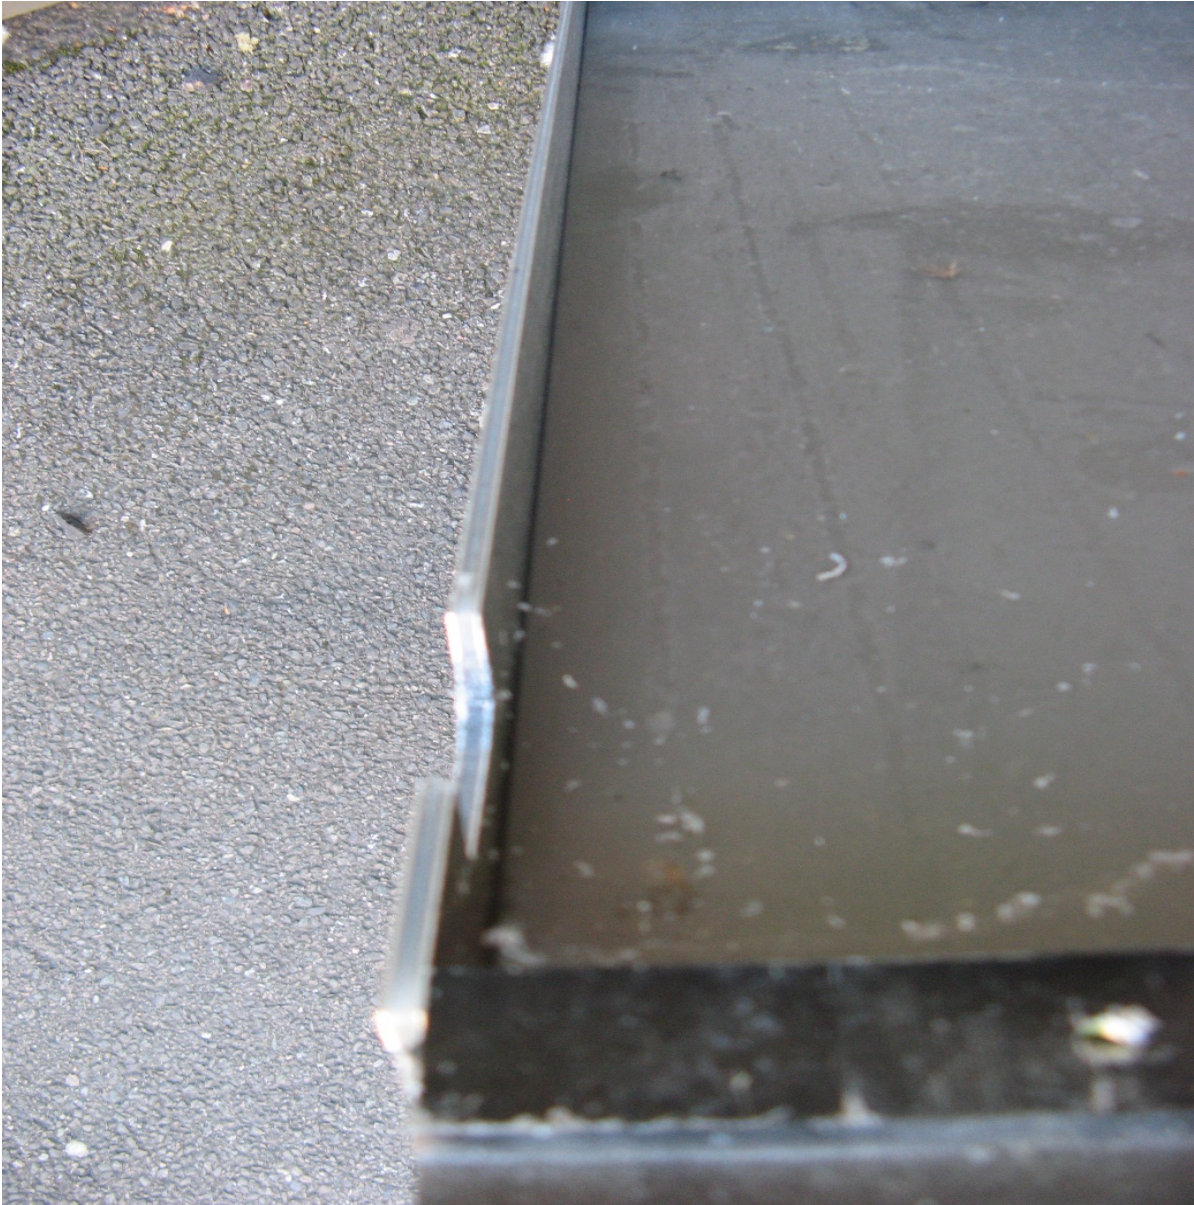
**Figure 10 – Inspection Area 1 - existing composite metal rainscreen cladding (ACM).**

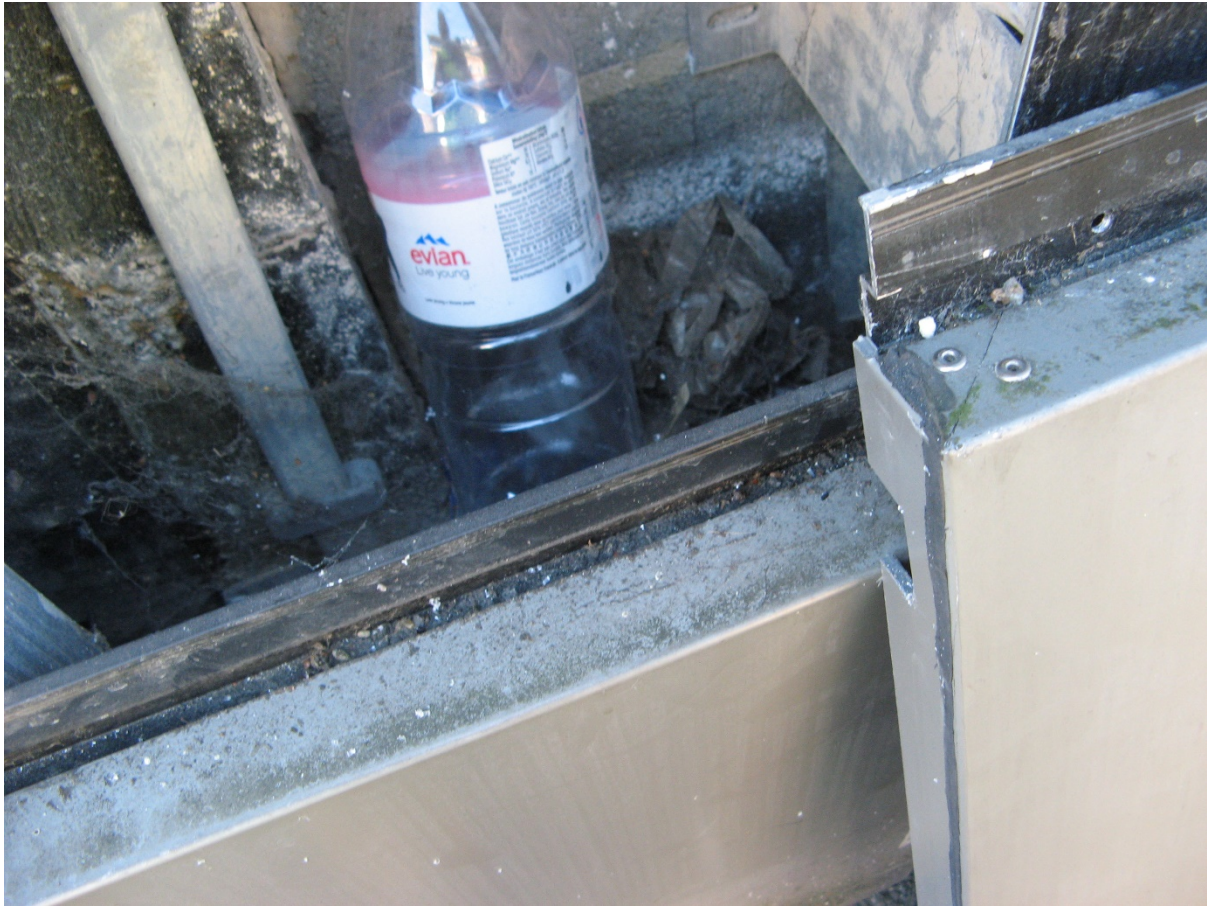
**Figure 11 – Inspection Area 1 - existing composite metal rainscreen cladding (ACM) at junction between SG curtain walling and tiled masonry, exposing blockwork substrate behind.**

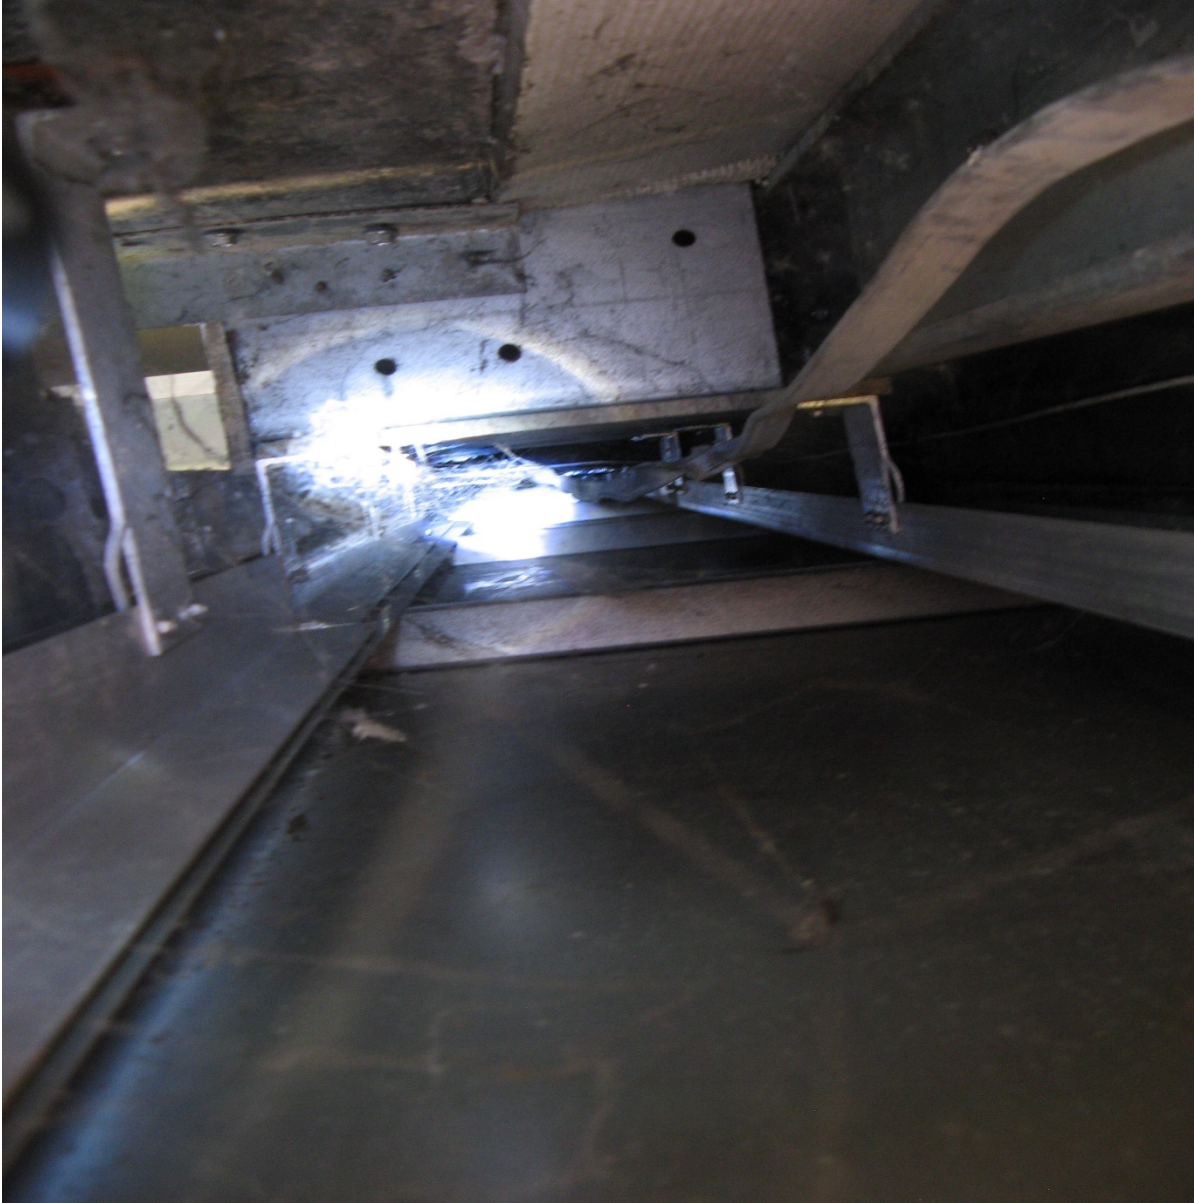
**Figure 12 – Inspection Area 1 - existing composite metal rainscreen cladding (ACM) at junction between SG curtain walling and tiled masonry, exposing blockwork substrate behind. Note there is no evidence of insulation and or fire-stopping within the cladding zone.**

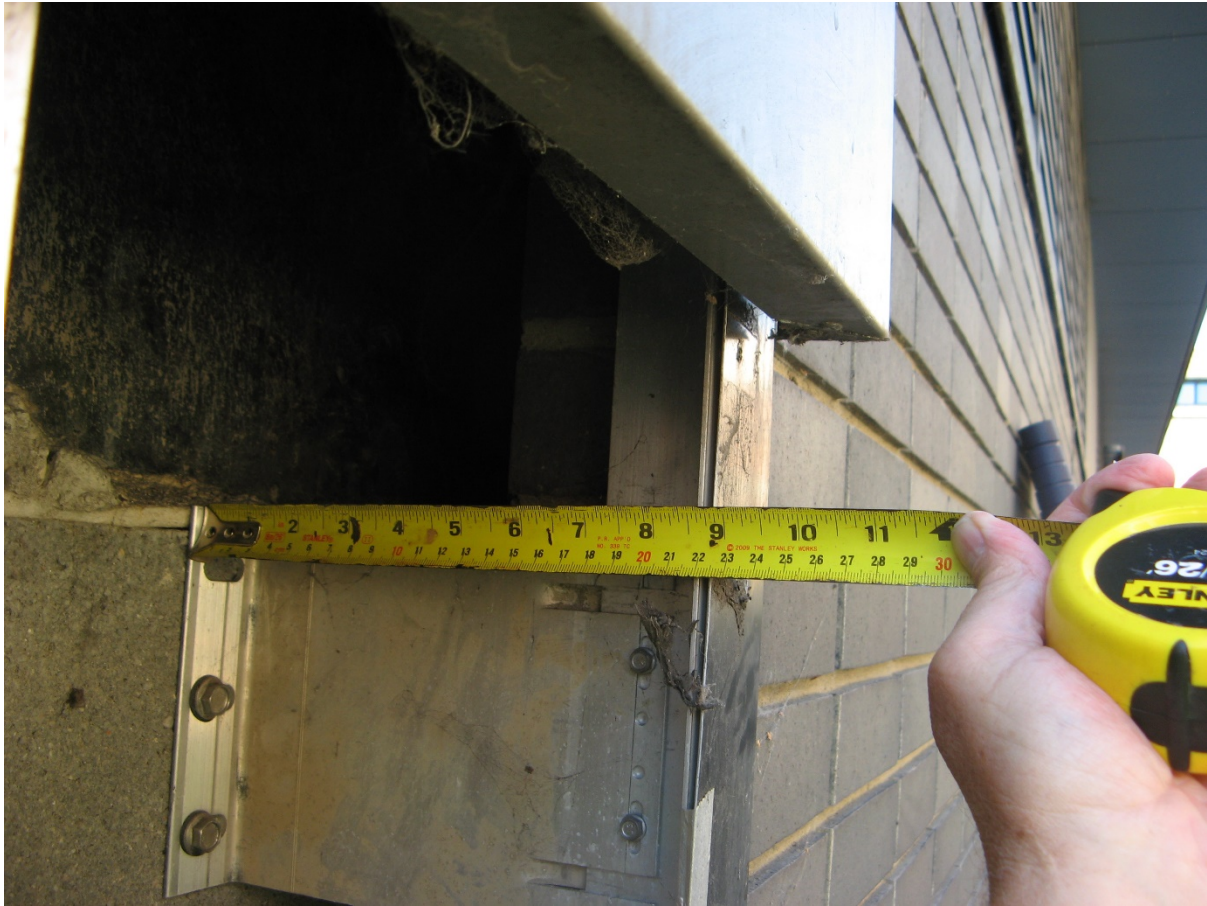
**Figure 13 – Inspection Area 1 - existing composite metal rainscreen cladding (ACM) aperture at junction between SG curtain walling and tiled masonry, exposing blockwork substrate behind. Note there is no evidence of insulation and or fire-stopping within the cladding zone.**

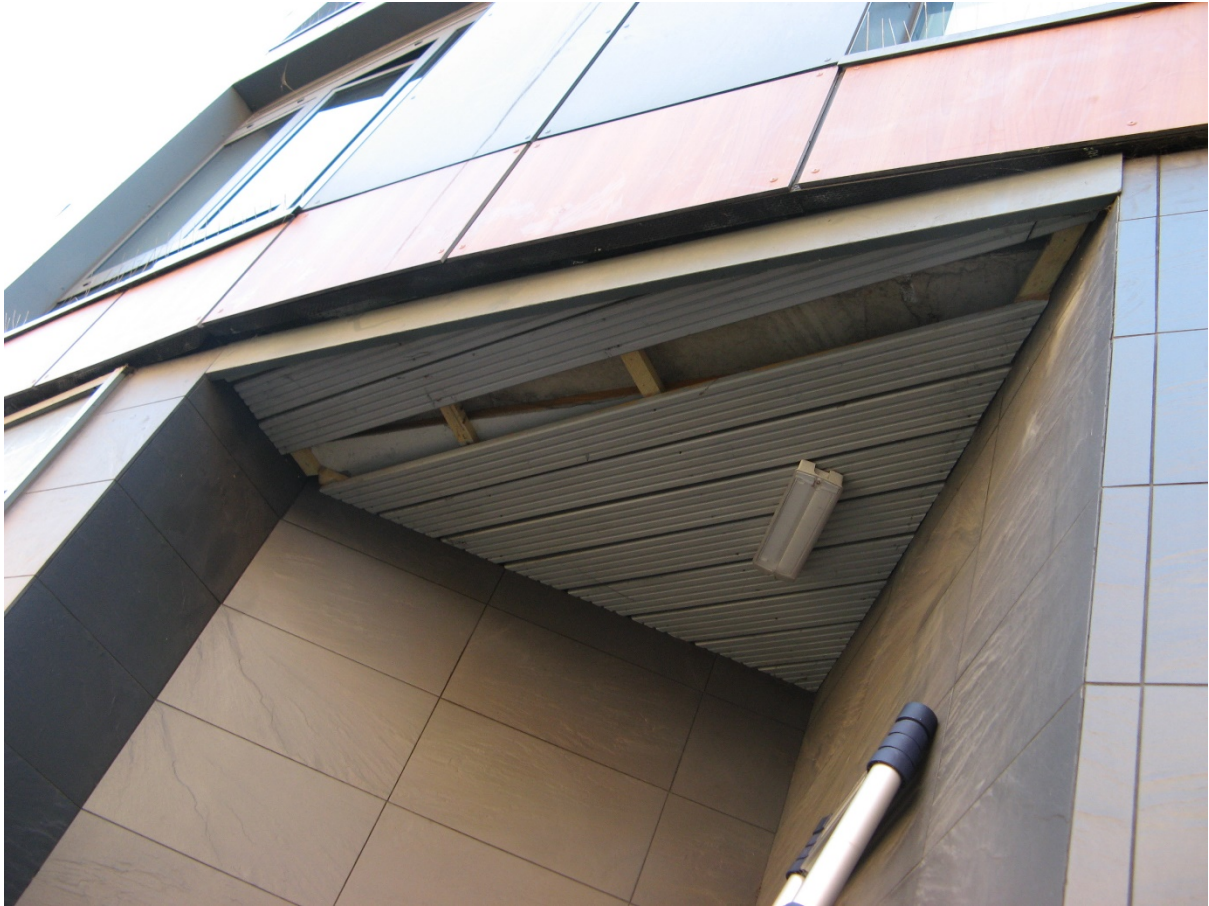
**Figure 15 – Inspection Area 2 – removal of existing fluted timber decking board to soffit.**

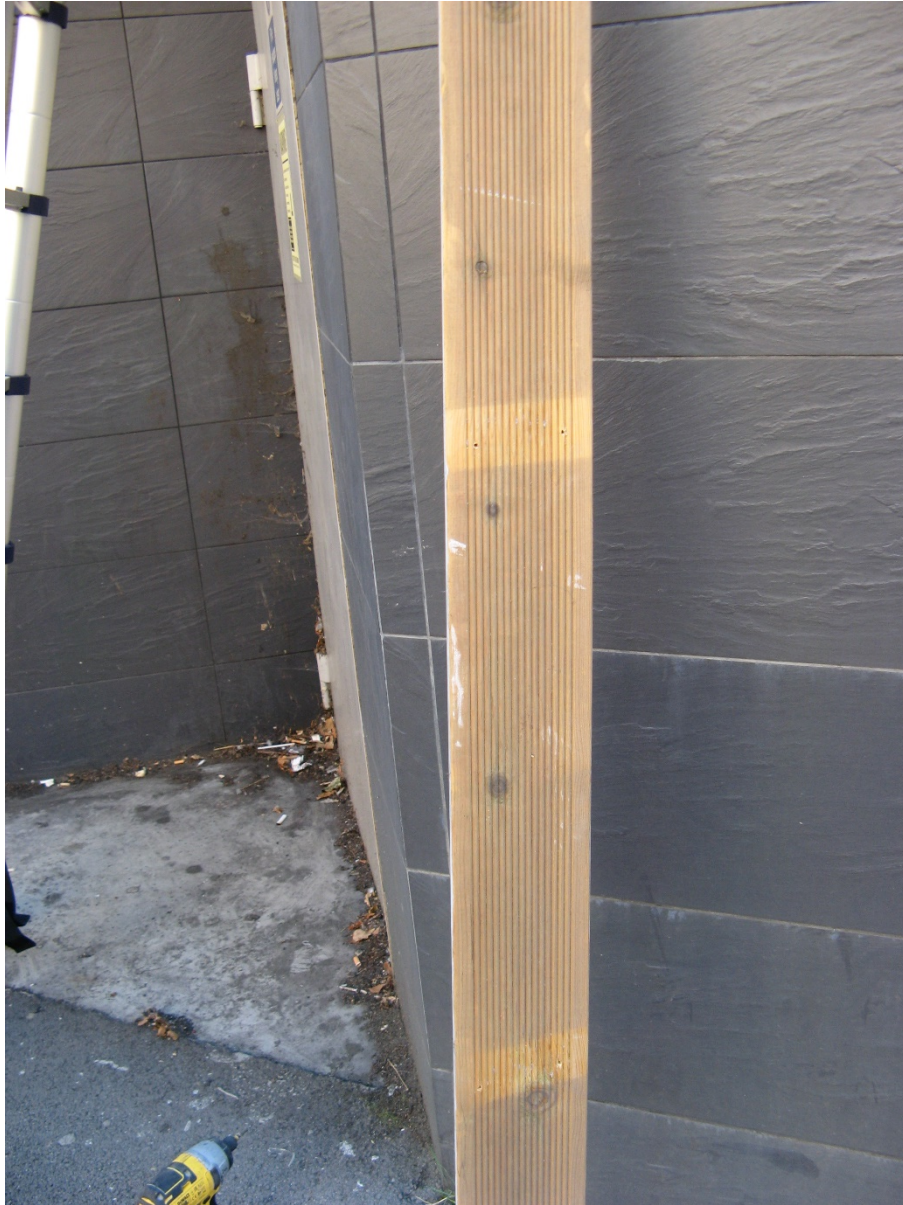
**Figure 16 – Inspection Area 2 - removal of existing fluted timber decking board to soffit.**

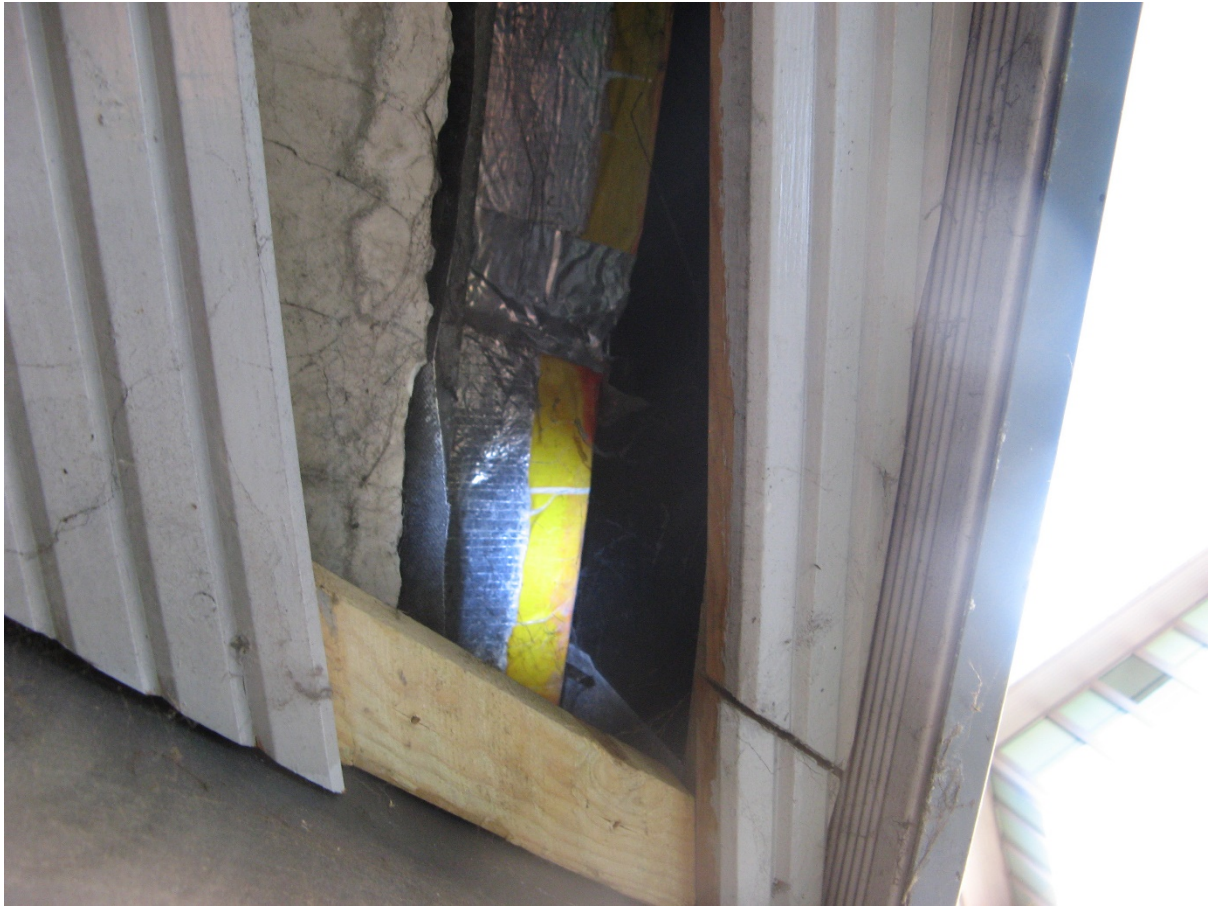
**Figure 17 – Inspection Area 2 - removal of existing fluted timber decking board to soffit fixed on softwood battens, revealing existing insulation to concrete slab edge above.**

In the consolidated government advice (MHCLG Consolidated Advice) it is the expert's opinion that the removal and replacement of combustible materials used in the pertinent façade construction is the clearest way to prevent external fire spread and therefore to meet the intention of the Building Regulations requirements this occur as soon as practicable.

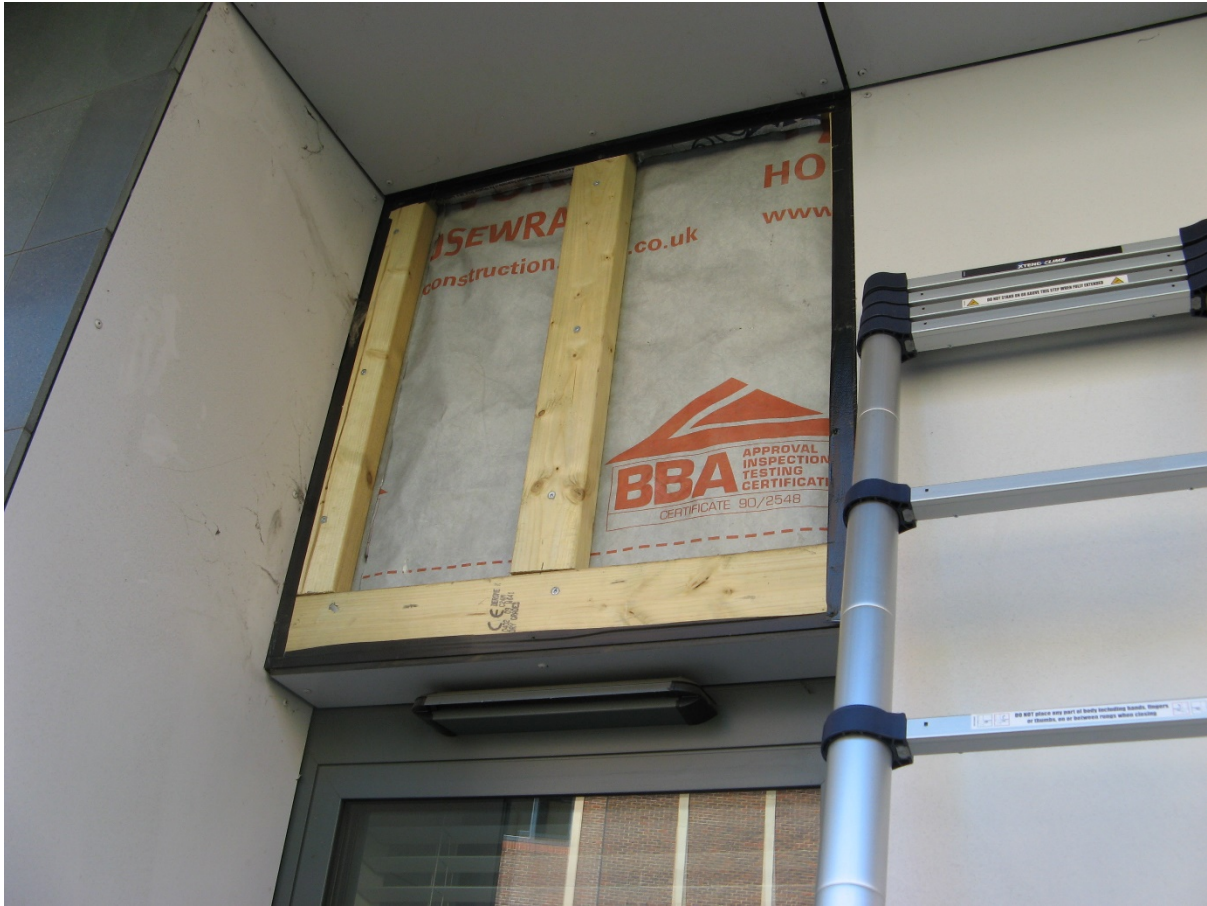
Figure 19 – Inspection Area 3 – removal of existing high pressure laminated board cladding
