Fire Risk Assessment Report

**Property Address:
Nobel House
4 Queensway
Redhill
Surrey
RH1 1TY**

Date: 09/02/2021

Document ID Reference: B8481/ FRA.V4

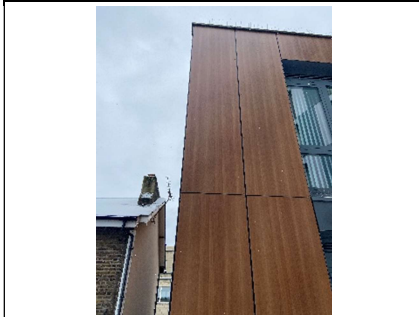
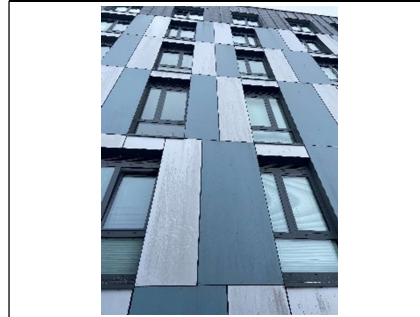
2.6	<p>It was noted that cladding materials have been incorporated into the external wall system. It has not yet been confirmed that the materials used are of limited combustibility in accordance with BS EN 13501 (classified as A1 or A2-s1, d0), or that the system has achieved BR135 classification by passing a BS 8414 test.</p> <p>In addition, timber materials are incorporated into the construction of the front external balconies.</p>	<p>Residents, Management Staff, Visitors, Contractors</p> <p>Combustible materials used in the external wall system present a potential source of rapid fire spread.</p>	<p>Delco has been advised that a consultant has been engaged to carry out an appraisal of the external walling system.</p> <p>Operatives were observed on site at the time of the inspection undertaking these works.</p>	M	H	H	<p>Verification of the fire performance of the external walling system should be obtained. This should include an assessment of whether any cavity barriers and fire stopping have been installed correctly, and whether the system has been maintained appropriately.</p> <p>If it cannot be confirmed that the external walling system/attachments are of limited combustibility in accordance with BS EN 13501 (classified as A1 or A2-s1, d0), or that the system has achieved BR135 classification by passing a BS 8414 test, urgent professional advice on the measure(s) which need to be taken to ensure that the external walls meet an appropriate standard of fire safety should be sought. This advice should be obtained from a Chartered Engineer with suitable specialist experience of the assessment of external walling/cladding systems.</p> <p>Unless, by the time of issue of this report, findings related to the examination of the external walling system (including balconies) have confirmed that the standard set out above has been met, it is recommended that the temporary adoption of a simultaneous evacuation strategy is implemented. This would require the implementation of a waking watch</p>	L	M	L

Issue ID Reference: 2.6
Example of external wall system/
cladding.

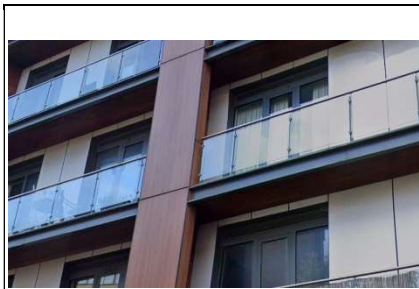
Issue ID Reference: 2.6
Timber balconies to front of
property.

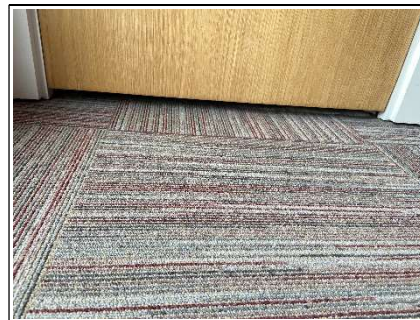
4.1	<p>The following compartment fire doors were observed to have significant threshold gaps:</p> <ul style="list-style-type: none"> The riser shaft fire doors located to the LHS of the lift on 1st – 6th floors. Tank room within the plant room. The plant room door. LHS stairwell, ground floor door to the small car park. TV and stopcock cupboard doors on 1st and 2nd floors. Bicycle store doors 	<p>Residents, Management Staff, Visitors, Contractors</p> <p>The common stairwell serving as the primary escape route from the property is not adequately protected against the spread of fire/ smoke.</p>	<p>Several of the remaining compartment fire doors had been fitted with automatic threshold seals where gaps had previously been identified.</p>	L	H	M	<p>Gaps along the bottom edge of any fire door should not exceed 10mm, where this is exceeded the door should be adjusted to compensate for the gap without compromising the allowable 3mm gap on side and top edges of the door. Where adjustment is not sufficient and if there is sufficient test data evidence to support it, it is recommended that an approved threshold seal is fitted to the door. If upgrading the door is found to be impractical, the door should be replaced with a FD30S self-closing door set compliant to BS476-22 or BS EN 1634.</p> <p>Additional Comments:</p> <ul style="list-style-type: none"> All fire doors should remain closed when not in use. 	L	L	L

Issue ID Reference: 4.1
Example threshold gap to
compartment fire door.

4.1 cont:	leading to alternative exit within the large car park.						<ul style="list-style-type: none"> • Fire doors should be regularly inspected for damage that may prevent the door from performing in the event of a fire. • Periodic checks should be carried out at least once every six months. • Doors where traffic is high are likely to be more susceptible to damage and should be checked more frequently than other doors in the building. E.g. once per week/month (depending on usage). <p>Newly occupied buildings may require more frequent checks in the first year of use.</p>

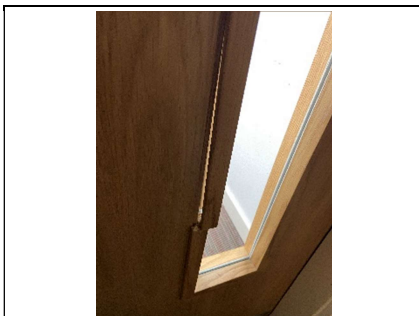
4.2	<p>The beading to the incorporated glazing in the following fire doors was observed to be damaged:</p> <ul style="list-style-type: none"> • 4th floor fire door adjacent to flat 79. • 3rd floor fire door adjacent to the meter cupboard. • 2nd floor fire door adjacent to flat 35. 	<p>Residents, Management Staff, Visitors, Contractors</p> <p>The common stairwell serving as the primary escape route from the property is not adequately protected against the spread of fire/ smoke.</p>	None.	L	H	M	<p>Damaged doors may be repaired in accordance with an 'Accepted Repair Technique (ART)' in accordance with specification provided by a relevant UKAS accredited body (e.g. BM Trada), provided that the work is in accordance with the manufacturers test data.</p> <p>Arrange for a competent contractor to fully inspect the fire doors identified and undertake remedial/ replacement actions accordingly.</p>	L	L	L

Issue ID Reference: 4.2
Example of damaged beading to
glazing of fire doors.

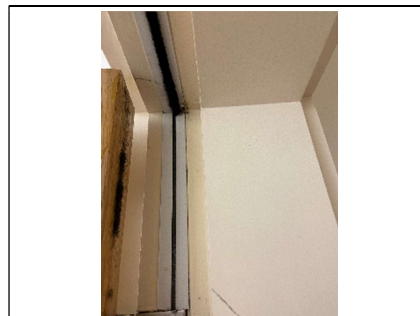
4.3	<p>The following fire doors were found to have damaged or missing intumescent strip and/ or cold smoke seals:</p> <ul style="list-style-type: none"> Intumescent strip and cold smoke seal was missing along the top frame edge of the fire doors to the 5th floor lift lobby. A section of smoke seal on the lower part of the leading edge of the door to the 4th floor lift lobby was damaged. Section of smoke seal missing on the top of the hinge edge on the fire door on the 1st floor adjacent to flat 5. Automatic threshold seals were observed to be faulty on the 2nd floor RHS stairwell doors. 	<p>Residents, Management Staff, Visitors, Contractors</p> <p>The common stairwell serving as the primary escape route from the property is not adequately protected against the spread of fire/ smoke.</p>	None.	L	H	M	<p>Damaged doors may be repaired in accordance with an 'Accepted Repair Technique (ART)' in accordance with specification provided by a relevant UKAS accredited body (e.g. BM Trada), provided that the work is in accordance with the manufacturers test data.</p> <p>Arrange for a competent contractor to fully inspect the fire doors identified and undertake remedial/ replacement actions accordingly.</p> <p>Additional Comments:</p> <ul style="list-style-type: none"> All fire doors should remain closed when not in use. Fire doors should be regularly inspected for damage that may prevent the door from performing in the event of a fire. Periodic checks should be carried out at least once every six months. Doors where traffic is high are likely to be more susceptible to damage and should be checked more frequently than other doors in the building. E.g. once per week/month (depending on usage). Newly occupied buildings may require more frequent checks in the first year of use. 	L	L	L

Issue ID Reference: 4.3
Example of damaged/ missing
seals to fire doors.
